# Manhole Inspection Summary

Manhole # S29EE2020MH

Insp Date: **12/21/06 11:26 AM**

**Location** Address: **2 MELROSE AVE**

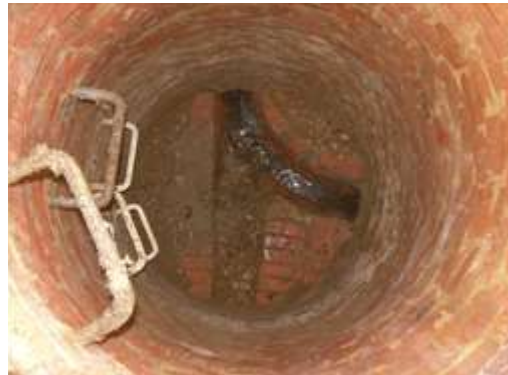
Top View

Bench and Channel debris.

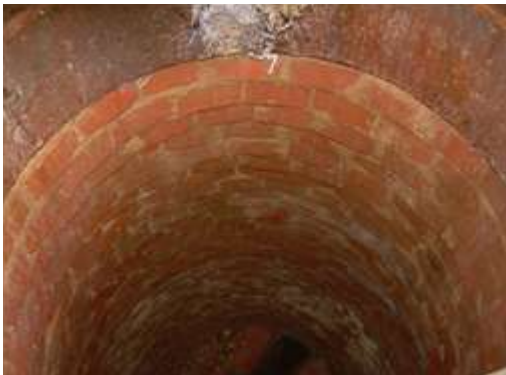
Defect

Adjustment and Barrel infiltration - other side.

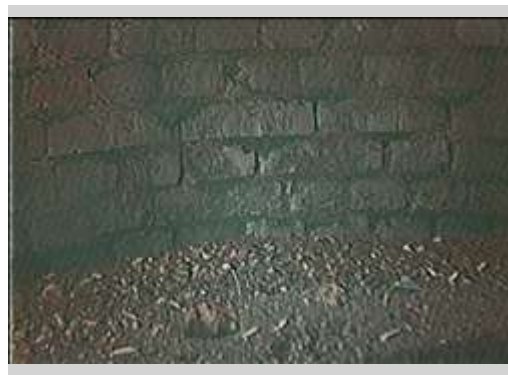
Defect

Condition: ☐ Sound ☐ Cracked ☐ Root Intrusion ☐ Loose Brick ☒ **Deteriorated**

Infiltration: ☐ None ☐ Joint ☐ Cracks ☒ **Mortar** ☐ Roots ☒ **Wall**

Barrel deterioration and infiltration.

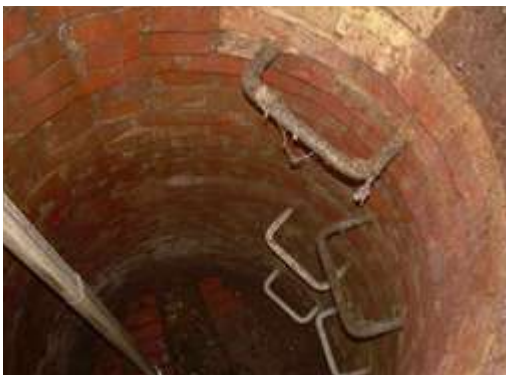
Defect

Infiltration: ☐ None ☒ **Joint** ☐ Cracks ☐ Mortar ☐ Roots ☒ **Wall**

Adjustment and Barrel infiltration.

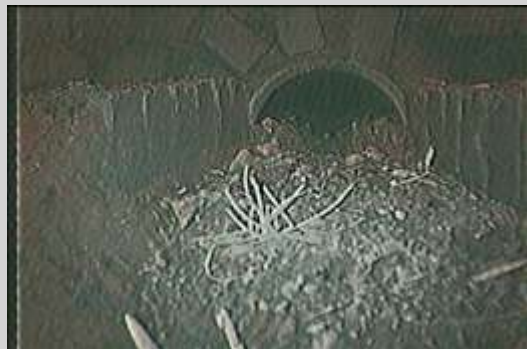
Pipe In @ 6 O'Clock

Channel debris.

Deposits: ☐ None ☒ **Mud** ☐ Sludge ☒ **Debris** ☐ Grease

Silt Depth: **4** (in.)

Deposits Extent: **Heavy**

Infiltration: **Evidence**
